Effects of Various Deicing Chemicals on Pavement Concrete Deterioration

HYOMIN LEE, ROBERT D. CODY, ANITA M. CODY, AND PAUL G. SPRY

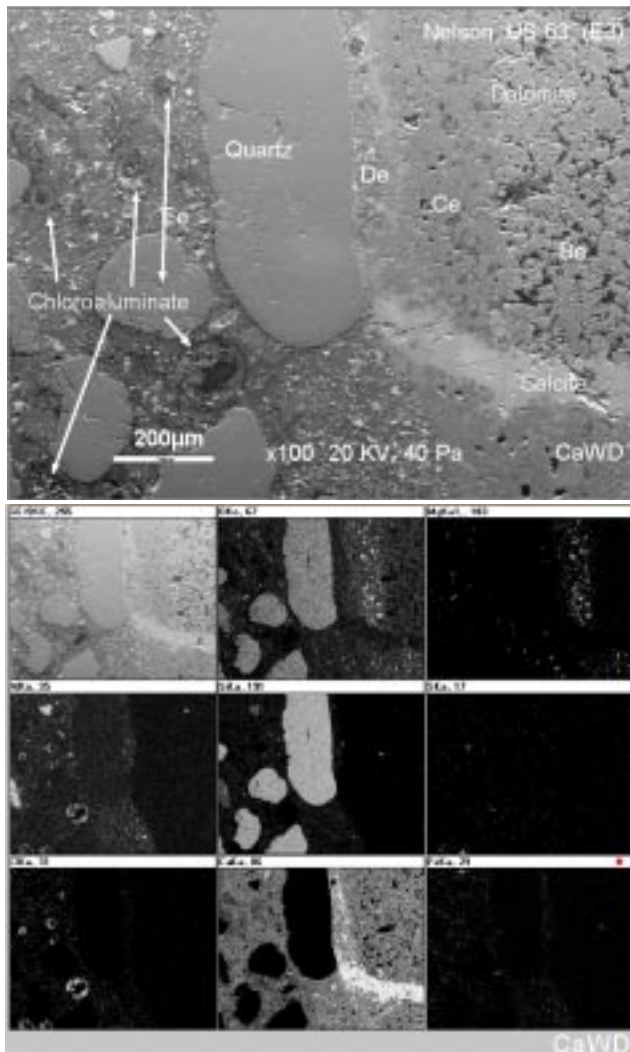
FIGURE 1 SEM micrograph and EDAX element maps showing experimentally-induced deterioration after wet/dry cycling in CaCl_2 of Nelson quarry concrete, US 63. Abundant brucite precipitated in the interstitial voids of a light-colored dolomite rim (Zone Ce). In air entrainment voids, areas rich in Ca, Al, and Cl probably are chloroaluminate. The limited S concentrations at the margins of air-entrainment voids indicate chloroaluminates have replaced ettringite that occurs abundantly in untreated concrete voids.

Calcium chloride deicing salts especially affected those concretes containing reactive dolomite aggregates by enhancing dedolomitization reactions that release magnesium to form brucite and magnesium silicate hydrate (MSH). Alteration rims observed after wet/dry and freeze/thaw conditions appear similar to those seen in untreated concrete, which had resulted from reactions between the reactive dolomite aggregate and paste during highway use. Major changes occurred in an outer light-colored dolomite aggregate alteration zone (FIGURE 1). The EDAX element maps show a decrease in Ca and

a concomitant increase in Mg in this region as a result of calcium chloride treatment. In these alteration rims, considerable volumes of calcite existed without significant quantities of brucite, but CaCl_2 produced abundant brucite and reduced the amount of calcite. An inner dark dolomite alteration zone and a light-colored cement alteration zone, both of which had developed during highway use, remained essentially the same as they were in untreated samples. In durable concrete with non-reactive dolomite aggregate, no alteration zone effects occurred during wet/dry or freeze/thaw cycling.

Calcium chloride affected the cement paste of both durable and non-durable concrete. The paste was markedly discolored. EDAX element maps show that Cl is concentrated in these areas (FIGURE 1). Chloride concentration may be due to the formation of calcium chloride hydrate ($3\text{CaO}\cdot\text{CaCl}_2\cdot 12\text{H}_2\text{O}$; $\text{CaO}\cdot\text{CaCl}_2\cdot 2\text{H}_2\text{O}$) or to

All chloride solutions produced chloroaluminate. Its morphology and occurrence in air-entrainment voids suggest that it is trichloroaluminate, $3\text{CaO} \cdot \text{Al}_2\text{O}_3 \cdot 3\text{CaCl}_2 \cdot 32\text{H}_2\text{O}$, resulting from the replacement of pre-existing ettringite (FIGURE 1) in which Cl^- substitutes for SO_4^{2-} ions in the ettringite structure:

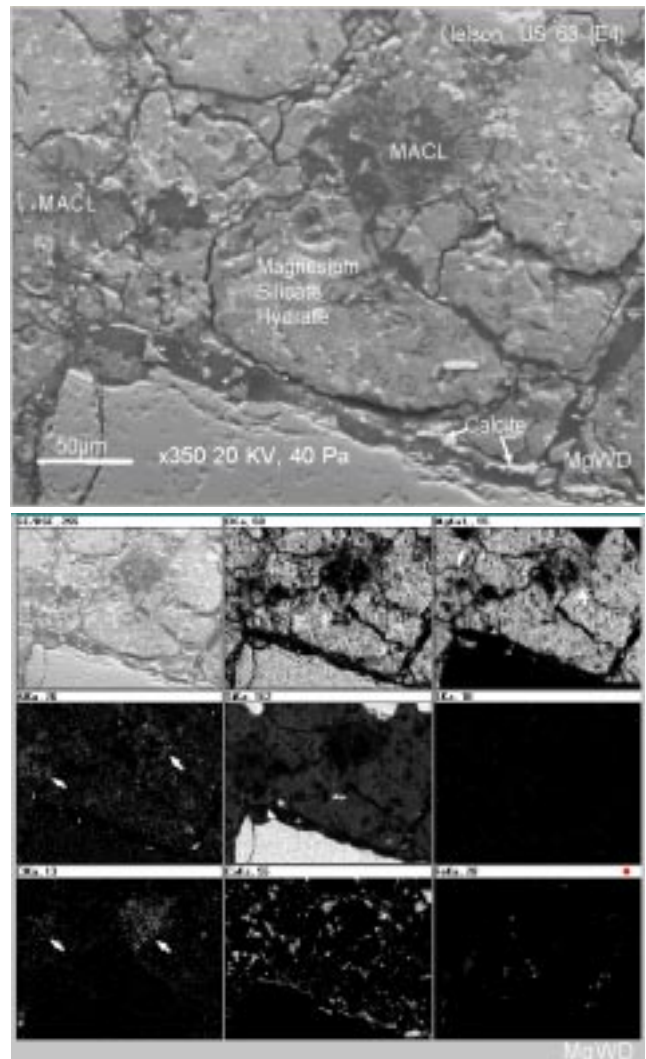
FIGURE 2 High magnification SEM and EDAX maps showing MSH features in cement paste. Abundant shrinkage cracks developed in the MSH as a result of experimental wet/dry cycling in MgCl_2 , and especially wide cracks formed at the boundary between quartz particles and cement paste. EDAX element maps and point analysis indicates that CSH in cement paste has largely changed to MSH. Calcium released by MSH formation migrated into open spaces and precipitated as calcite. Mg-, Al-, and Cl-rich material with minor Si, marked as 'MACL' formed in air voids.

Magnesium chloride produced significant concrete crumbling because of widespread replacement of CSH by non-cementitious MSH resulting from reactions between Mg^{2+} and the CSH cement phase (FIGURE 2). Abundant shrinkage cracks developed in the MSH. Using a modification of Bonen's (3) equation, the general reaction for the formation of MSH from CSH in Mg-chloride solution can be written as follows:

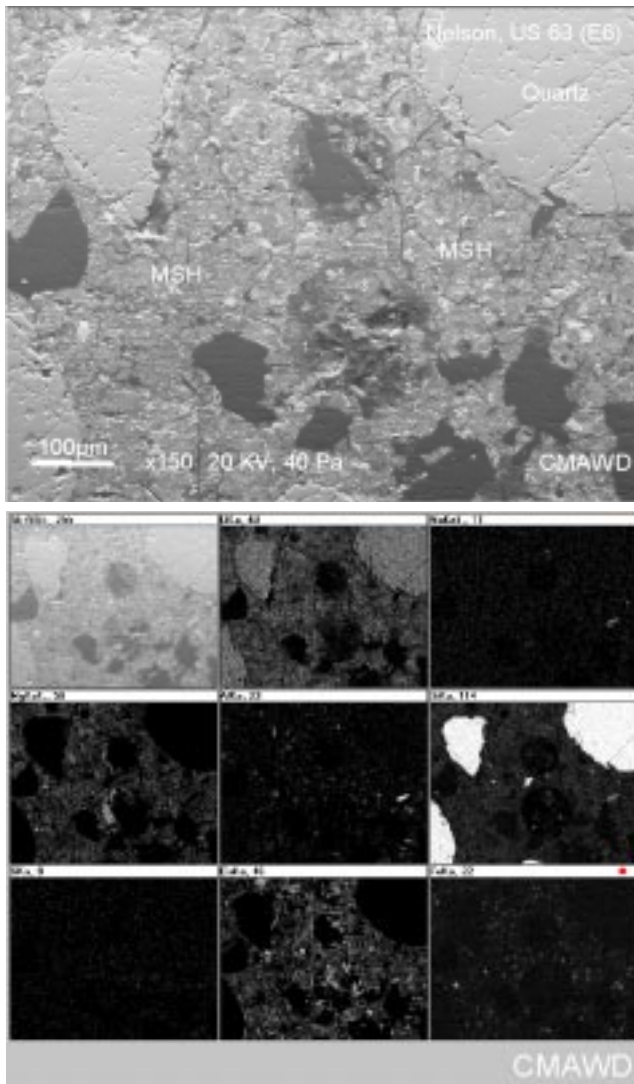
FIGURE 3 SEM micrograph and EDAX element maps showing the growth of brucite and calcite in Nelson quarry concrete from US63 after wet/dry cycling in CMA. Brucite (br) and calcite (Ca) grew in voids. Calcium silicate hydrate, CSH, in the cement has changed to magnesium silicate hydrate, MSH, with the development of abundant cracks. A wide solution channel, which appears to develop because of paste dissolution by CMA, formed between a limestone coarse aggregate particle and the surrounding cement. Note that Si-rich crystals are silicon carbide grains (Gr) from grinding powder used during thin-section preparation.

air voids and between the aggregate and cement paste where brucite also precipitated (FIGURE 3).

Another aggressive feature of CMA treatment was debonding of fine aggregate particles. As shown in FIGURE 3, CMA solutions penetrate the cement paste, especially along the boundaries between the fine aggregate and the cement paste where they react with the CSH at the paste/fine aggregate interface and form a thin layer of non-cementitious MSH. This MSH layer resulted in debonding of fine aggregate from the paste. Secondary brucite was then precipitated in the large voids created by loss of fine aggregate. As a result of the newly created voids, a series of new minerals were observed frequently in those open spaces.

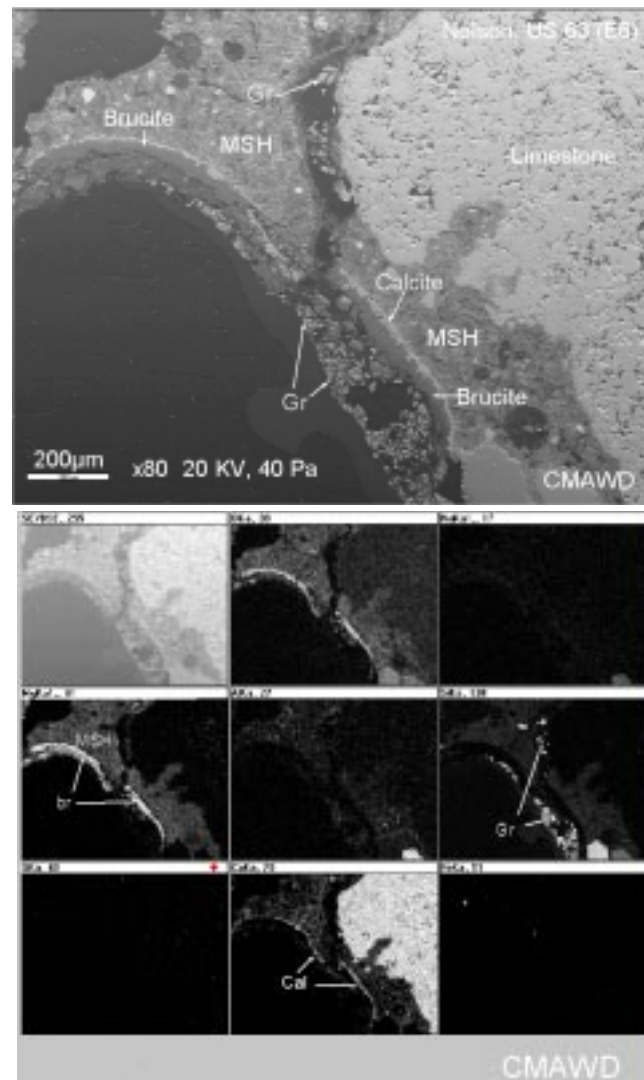
FIGURE 4 High magnification SEM and EDAX maps showing MSH features and void-filling minerals in cement paste. The cement paste has altered to MSH and abundant shrinkage cracks have developed as a result of CMA treatment. Calcium released by MSH formation migrated to tiny open spaces where it precipitated as calcite. Void-filling minerals show various compositions.
